Single Survey

Handa 18 Keose Glebe Lochs HS2 9JX

survey report on:

Customer	Mr and Mrs M Morrison
Customer Address	Handa 18 Keose Glebe Lochs HS2 9JX
Date of Inspection	27 th August 2014
Prepared by	Angus J Macaulay BSc MRICS Registered Valuer

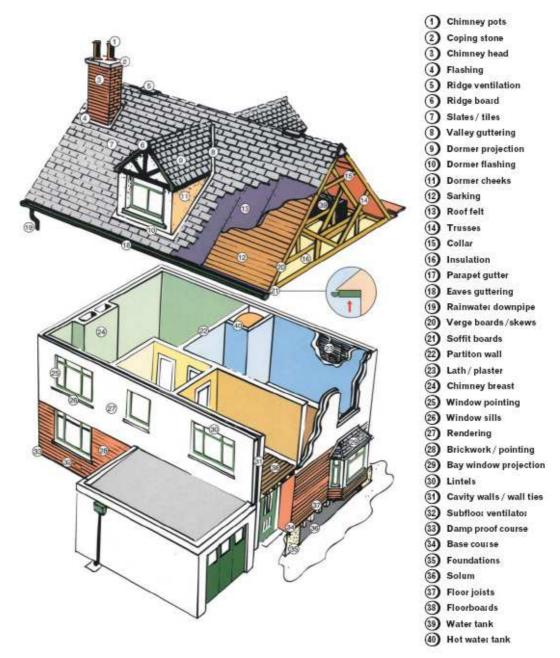
Sectional Diagram showing elements of a typical house

Reference may be made in this report to some or all of the above component parts of the property. This diagram may assist you in locating and understanding these items.
